Premature failure in motorcycle engine Suzuki model GSX-R750: Case study.

ABSTRACT: The study in question was carried out from the inspection of a failed engine of a Suzuki motorcycle model GSX-R750, about 27,343 km driven. The engine was disassembled and the parts were checked. The crankshaft rod bearing on the third cylinder of the engine was found completely damaged, without the smooth metal cover responsible for friction reducing and also partially broken. The probable causes, listed in specialized technical texts, are problems in the internal distribution of lubrication, improper assembly of the rod bearing or manufacturing defect of the component. It was concluded, based on the specific bibliography and knowledge of the author, that the failure did not occur due to operation or maintenance, but by inherent defect in the manufacture of the rod bearing

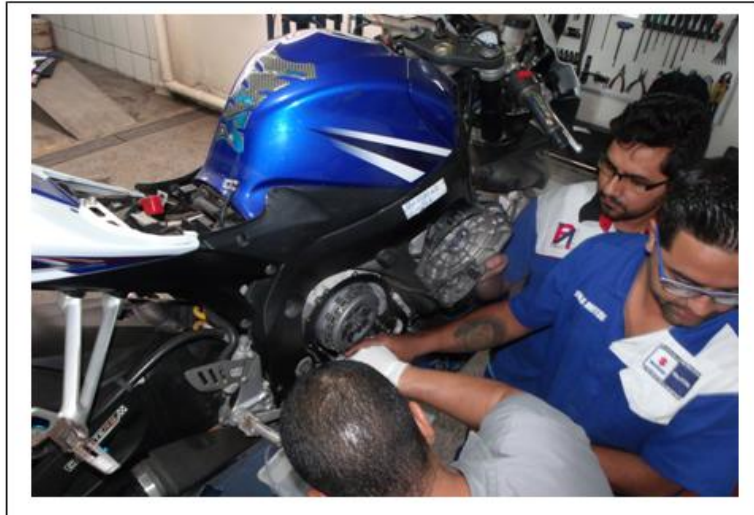
Figure 1 - Engine disassembly by technical Suzuki dealers.

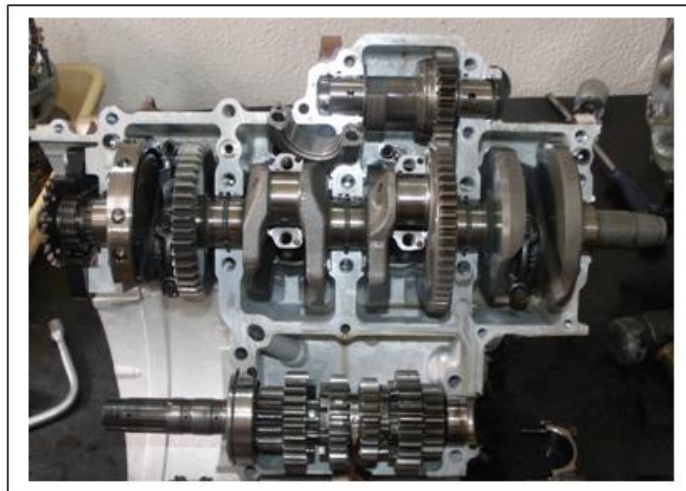
Figure 2 - Semi disassembled engine.

One of the possible place of the failure was on rod bearings, so the lower part of the motor was disassembled to access these components (Figure 2).

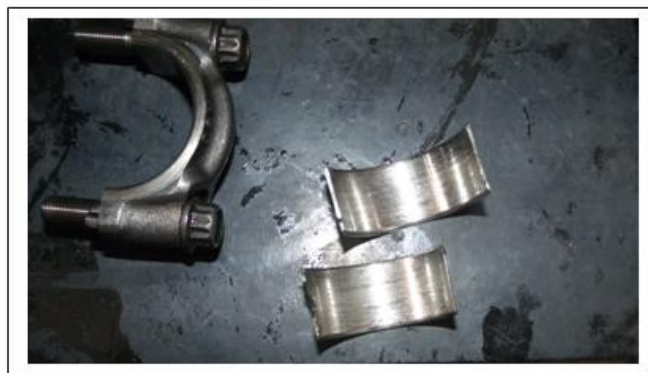
The identified failure mechanism was found only in the third-cylinder connecting rod bearing. The rod bearing was without the smooth metal and partially broken (Figure 3), which produced excess play in the set and grooves or marks on the crankshaft (Figure 4).

Figure 3 - Connecting rod bearing of the 3rd cylinder.

When analyzing the third-rod bearing of the engine as shown in figure 3, there are signs that, when compared with examples presented in the literature (Figure 6), may be caused by insufficient lubrication, it is verified that the smooth metal was eliminated, which can also be caused by material fatigue (SILVA; SILVA, 2005).

The possible cause for oil film reduction in the damaged bearing may be insufficient vertical clearance, oil dilution, long idling engine, partially obstructed oil gallery, incorrect choice of bearing thickness, inverted mounting, oil pump malfunction (MAHLE, 2016). According to Silva e Silva (2005), fatigue (Figure 7) can be caused early when there is no complete metallurgical union between the base metal and the smooth metal.

When evaluating the hypothesis of reduction of the lubricant film as the cause of the failure, it must be considered that the other bearings of the crankshaft and of the other connecting rods did not present problems. This excludes the possibilities of problem in the oil pump, oil dilution and of the long idle engine, as it would cause problems in all rod bearings. Thus, insufficient vertical clearance, partial obstruction of the lubricant distribution, incorrect choice of rod bearing thickness and inverted bearing assembly, could have caused premature failure of a single rod bearing.

Regarding insufficient clearance or incorrect choice of the bearing thickness, there has already been a change in the information in the service manual for the correct definition of the bearing for the main crankshaft bearings (SUZUKI TECHNICAL SERVICE DEPARTMENT, 2006). This information means that there may have been incorrect information on the selection of bearing on the assembly line and this possibility could extend to the connecting rod bearings.

In the assessment of the causes, it is concluded that it must have been originated by one or all of the following possibilities: insufficient rod bearing vertical clearance, incorrect choice of rod bearing thickness or failure due to fatigue. A manufacturing fault is then found, where a nonconforming component is hidden, collapsing within 300 hours of engine use.

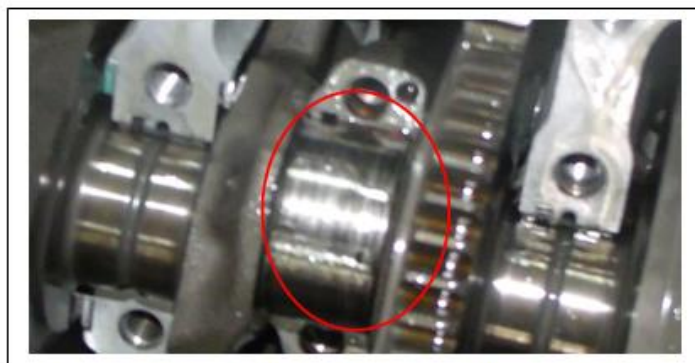
Figure 4 - Damaged sliding surface on the crankshaft.

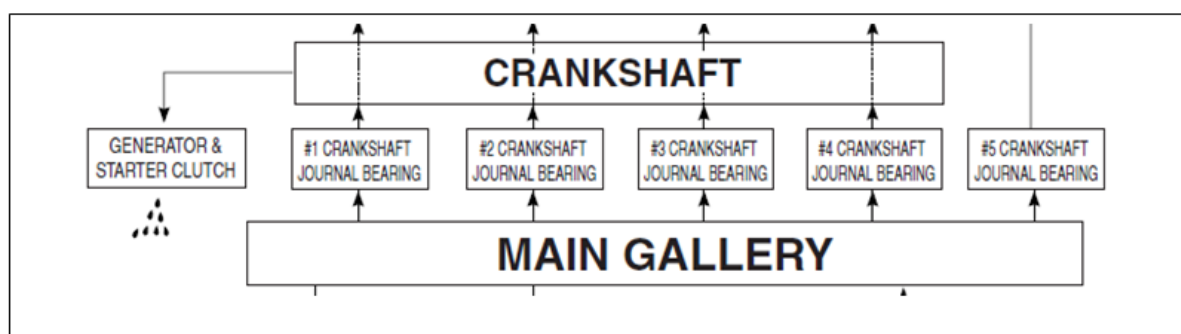
According to the driver's report when the symptoms of the fault appeared, the engine speed and temperature were among the recommended parameters of use, there was a change of engine noise and the warning symbol was displayed on the motorcycle panel, which, according to the vehicle's manual, indicates low oil pressure (SUZUKI MOTOR CORPORATION, 2009). The oil pressure in this engine model is taken in the main oil distribution chamber (Figure 5) and, according to the manufacturer; the pressure drop may have been caused by an insufficient amount of oil in the engine, a defective oil pump, clogging in the distribution circuit or use of an incorrect type of oil. However, all of these possible causes would also cause engine overheating (SUZUKI MOTOR CORPORATION, 2006), but during the fault the panel indicated a temperature of 87 ° C, indicating that there were no engine heating problems. On the other hand, the motor failure analysis manual also indicates bearing wear and leakage in the oil pump discharge line as factors that may cause the lubricating oil pressure drop (GIRUX-LUBRIFICANTES, 2010).

Figure 5 - Part of the schematic of engine diagram for lubrication distribution (SUZUKI MOTOR CORPORATION, 2006).

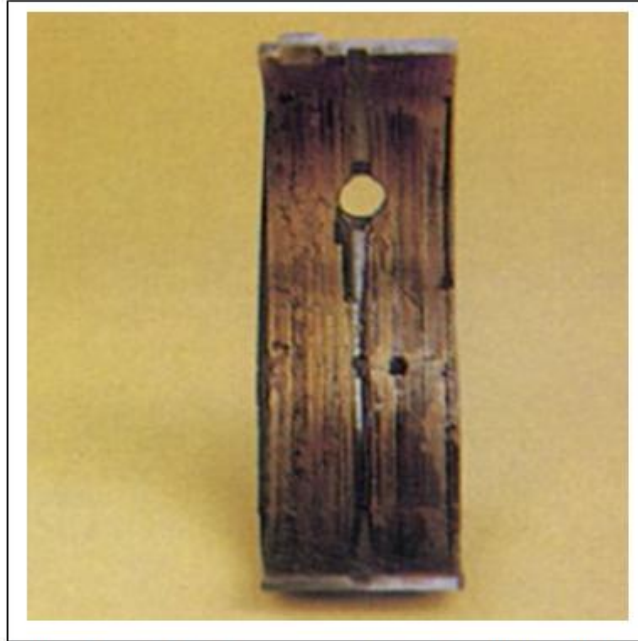
Figure 6 – Rod bearing worn caused by reducing lubricant film (MAHLE, 2016).

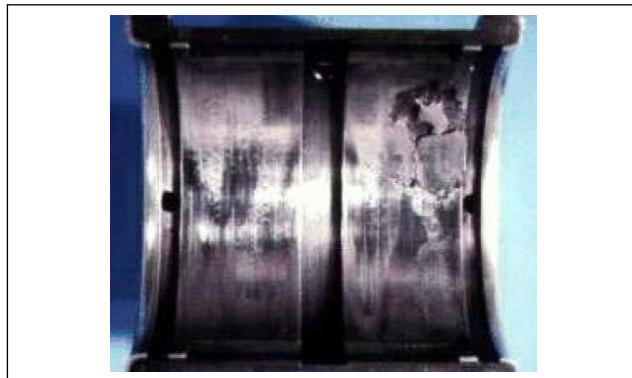
Figure 7 - Example of a premature fatigue failure in a rod bearing (SILVA, SILVA, 2005).

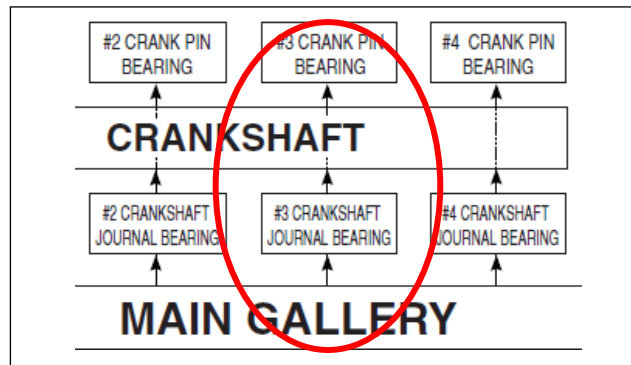
Partial obstruction of the oil flow could have caused the problem, if the crankshaft channel leading the oil received from the engine block to the third bearing rod, shown schematically in Figure 8, was stopped. If the third crankshaft bearing obstructed the oil passage hole, for example inverted mount, this problem could also occur, but no evidence of this type was found at the inspection. The crankshaft bearings have a hole in which the oil flows from the engine block to the channel in the crankshaft (Figure 9), which leads the lubricant to the bearing of the connecting rod, the channels in the crankshaft being independent for each connecting rod.

Figure 8 - Crankshaft bearing lubricating oil distribution scheme (SUZUKI MOTOR CORPORATION, 2006)

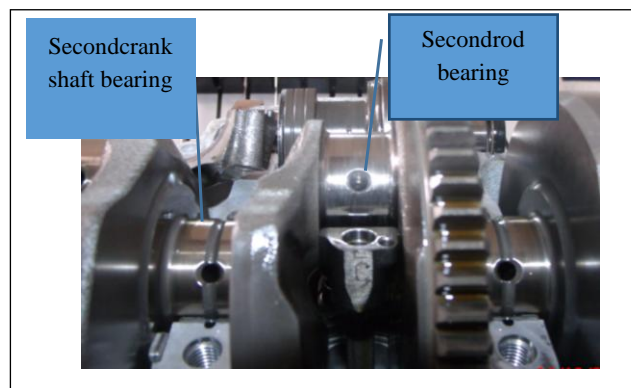
Figure 9 - Transmission points of the lubricating oil between the engine block and crankshaft.
