Post-Event Evaluation and Assessment of Flash Flood Dam Efficiency

ABSTRACT: Flash flood dams are critical for mitigating downstream hazards, but their effectiveness depends heavily on robust design and construction. This study presents a post-event assessment of the Matrouh Dam in Egypt, a 6-meter-high embankment structure that failed to retain impounded water, releasing ~80% of its 200,000 m³ storage within 72 hours after its first flood event. Through integrated field investigations (including borehole sampling, land surveys, and visual inspections), laboratory permeability testing (ASTM D5084), and 2D finite element modeling (DIANA software), we identify the causes of premature water release. Three numerical scenarios were evaluated: (1) baseline design conditions, (2) an inefficient upstream riprap layer (simulating construction defects), and (3) a compromised core with doubled permeability. Results demonstrate that construction flaws—particularly mortar failure in the upstream riprap layer and elevated permeability in core materials—enabled rapid seepage through the dam body and foundation. Scenario 2 closely mirrored the dam's actual failure mode, underscoring the upstream

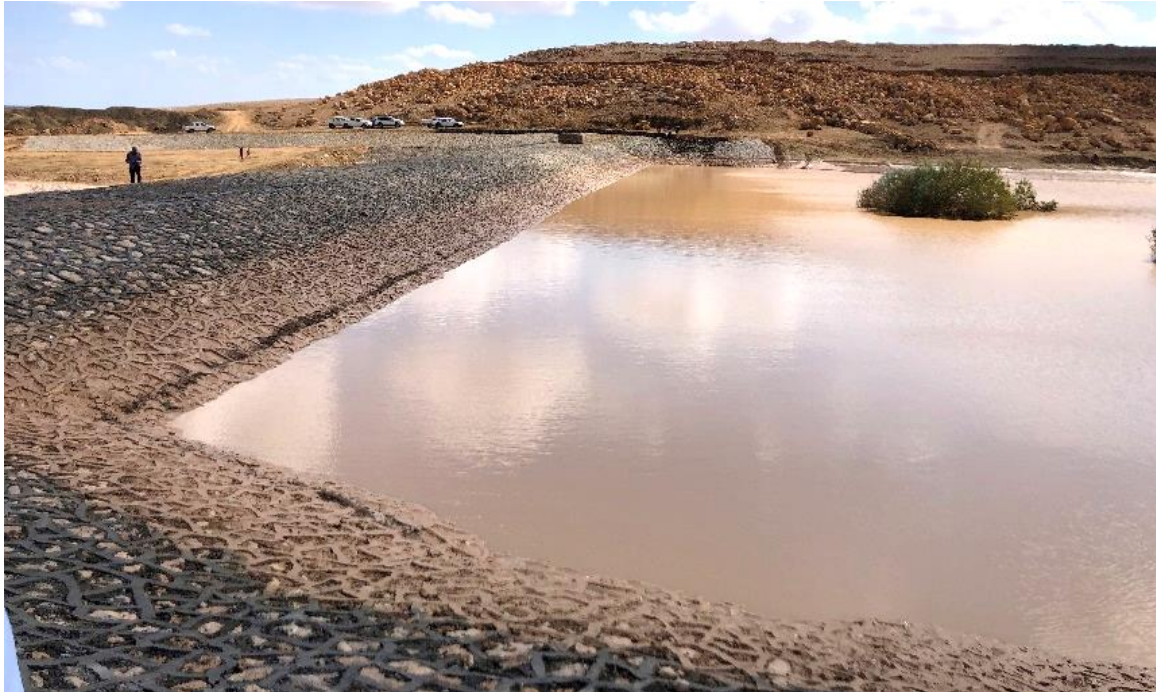
After the first significant flood event, the dam exhibited higher-than-expected seepage levels. Over two days, approximately three meters of the stored water leaked out. Within a week, the entire reservoir had emptied due to excessive seepage through the dam body and underneath its foundation. These issues with seepage and leakage compromised the dam's ability to retain water, raising concerns about the dam's structural integrity and long-term performance. Figure 2 illustrates the seepage issues and their impact on the water levels within the dam's reservoir.

Figure 2: Post-Storm Condition of Matrouh Dam.

The visual inspection showed some defects in the upstream face, such as a water vortex at the upstream apron and some failure in the mortar between ripraps, which is supposed to be the reason for the water flow inside the dam. Active seepage locations on the upstream slope were documented and monitored. So, Accurate data collection is fundamental to maintaining the validity and reliability of the analysis. A soil investigation was implemented at the dam, and two boreholes were drilled within the dam body, which extended 5 m underneath the dam. In addition, open excavations were conducted within the dam to check the condition of the inner layer and the rock material. In addition, there were no differential settlements, and any visible cracks were recorded, however, there were different locations of mortar loss between the ripraps. The layer of mortar underneath the riprap of the dam was not constructed well.

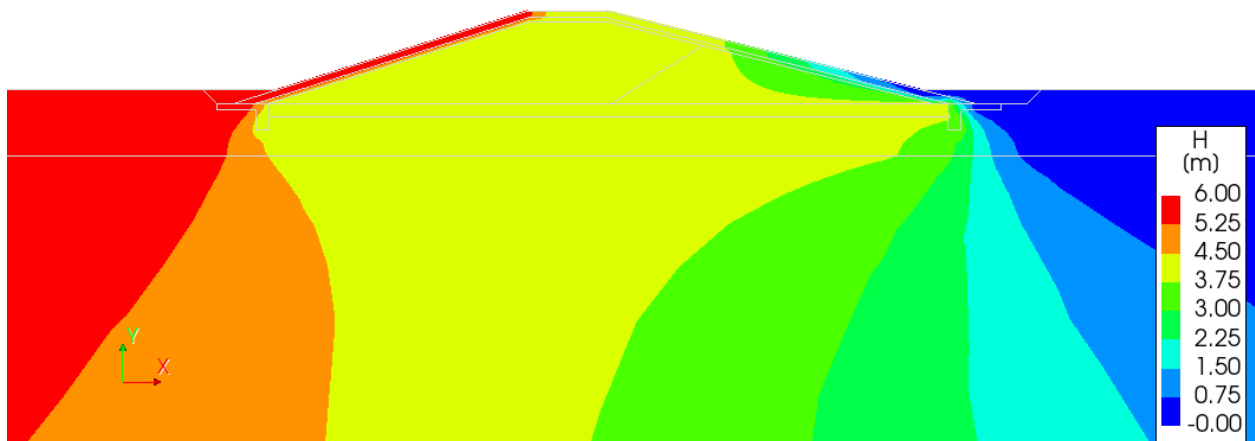
Simulation results indicated that under these ideal conditions, the upstream face is mainly responsible for restricting water, and around 10 % of the head is dropped within the upstream layer, with minimal seepage reaching the downstream face. Water retention was stable, and the drawdown curve remained gradual. However, this scenario does not reflect the post-event reality observed during site inspections, indicating that actual dam conditions deviate significantly from the design. Figure 5

Figure 5: Pressure head within the dam and foundation (Baseline Scenario)

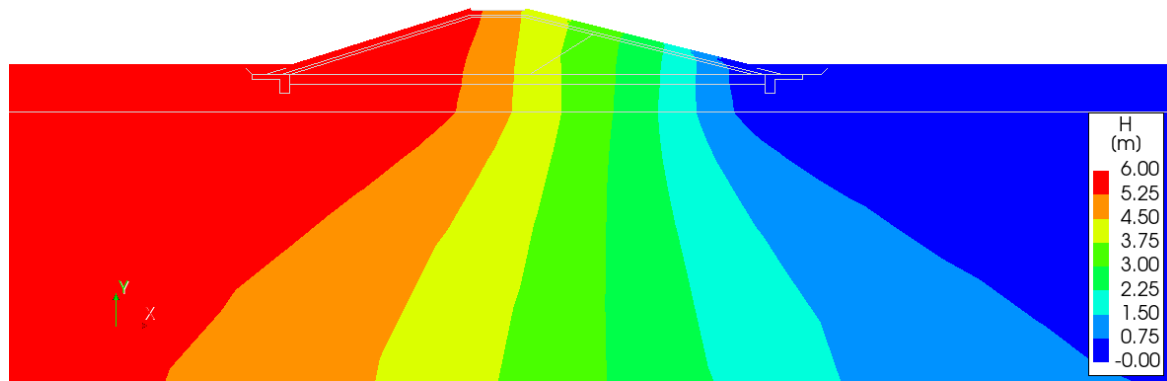
In this scenario, the upstream shell material was modeled with permeability values equivalent to the core, simulating construction flaws such as the use of improper fill material or inadequate compaction. This change resulted in a significant alteration in seepage pathways.

The simulation revealed that high permeability in the upstream layer allowed rapid infiltration into the dam body, accelerating saturation of the core. This scenario reflects the dam's *actual condition during the flash flood event*, highlighting the consequences of inefficient upstream zoning and the failure to isolate seepage within low-permeability materials, Figure 6

Figure 6: Pressure head within the dam and foundation (Scenario 2)

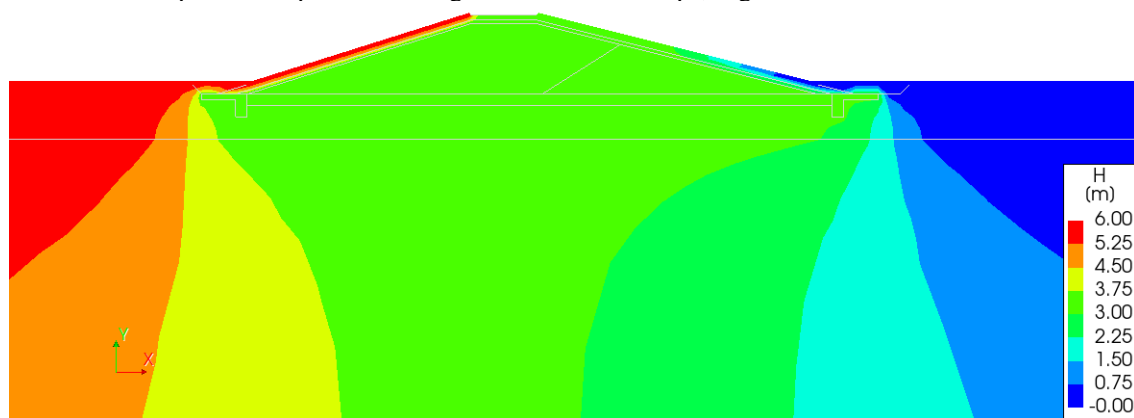
This model simulated a condition where the core (inner layers) permeability was twice as high as the design value, representing internal degradation, differential settlement, or construction deficiencies such as incomplete compaction. While the upstream and downstream shells maintained standard permeability, the compromised core significantly altered internal water flow dynamics, describing the dam behavior after retrofitting the upstream face and the critical case of weak material within the core. Results showed that seepage quickly propagated through the core and increased pore water pressures along the downstream slope, Figure 7

Figure 7: Pressure head within the dam and foundation (Scenario 3)

Results demonstrated the upstream layer's vital role in reducing hydraulic head within the dam core and ensuring structural stability. Critically, retrofitting the upstream layer to restore impermeability significantly enhanced dam safety in Scenario 3. These structural inefficiencies, driven by permeability mismatches, compromised the dam's core flood attenuation function.
