Health Monitoring of Reinforcement In Concrete Piers In A Barrage Project

S. N. Sharma¹, Pankaj Sharma², R. P. Pathak³, Sameer Vyas⁴, N. V. Mahure⁵,
S. L. Gupta⁶

(Central Soil and Materials Research Station, New Delhi, India)

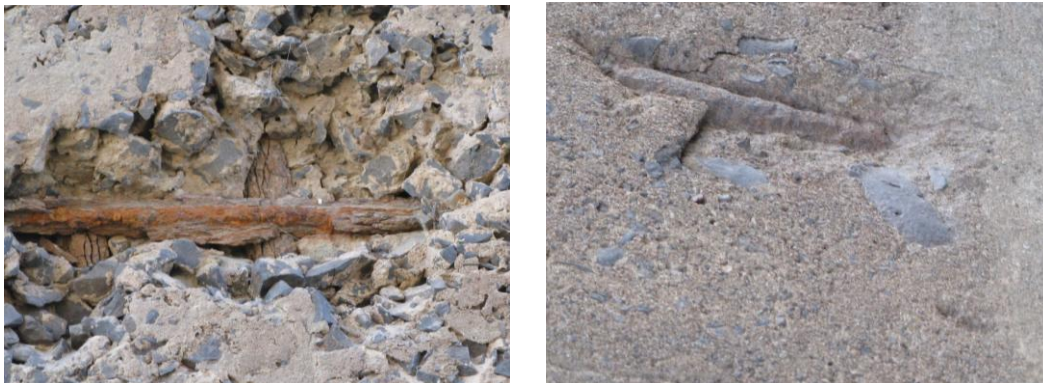
Corrosion problems are very common in almost all aspects of technology resulting in cropping of variety of problems. Corrosion damage in the reinforcement is an enormous economic liability. In a barrage project piers are constructed using concrete of different grades. The permeated water causes corrosion of reinforcement leading to weakening of structure [1] and spalling of cover (Fig. 1.1).

Fig. 1.1 Exposed reinforcement in piers due to spalling of cover

Since indications of deterioration of concrete and reinforcement have been observed a strict vigil through periodic monitoring of these piers should be kept using Non Destructive Tests.

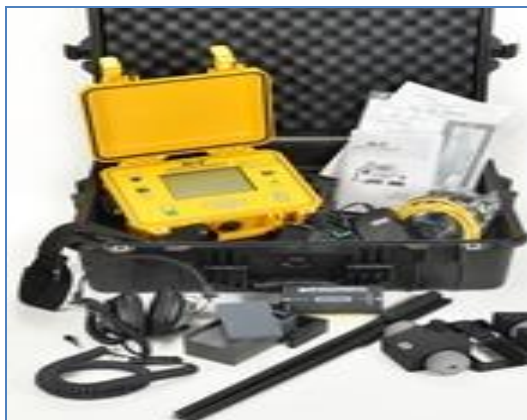
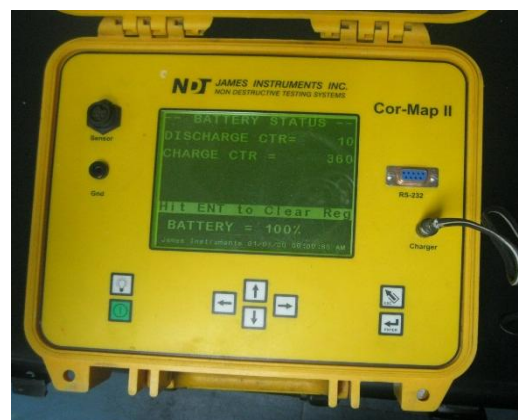
Micro Cover Meter

Half Cell Surveyor

Fig 3.1. Equipments Deployed for Investigation

The micro cover meter has been used to locate the rebar [4]. The concrete surface was examined for the exposed rebars/or got exposed to get a reference point. Surface was made wet and observation locations were marked on the surface [5]. The pre-activated Cu-CuSO₄ Half Cell was used to take observation.

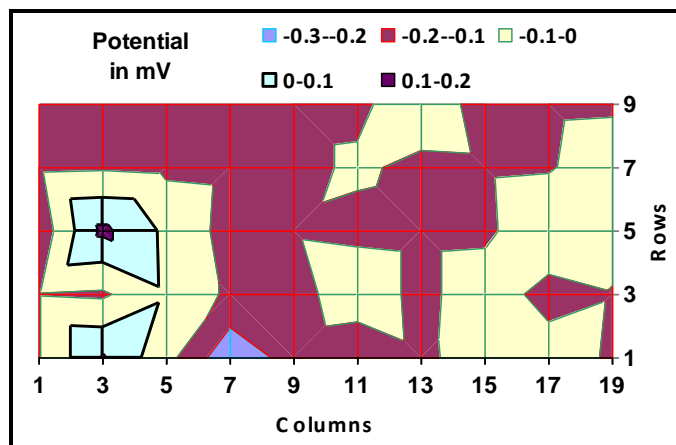
6.1. Pier 1

Only 2% region falls in 'D' category depicting uncertain corrosion activity while remaining 98% (6% in 'E', 70% in 'F' and 22% in 'G') area falls in categories which are indicative of no noticeable corrosion activity in the scanned area of the pier.

Fig. 6.1 Contour Map Showing Corrosion Status

Fig. 6.2 Pie Chart of Scanned Area

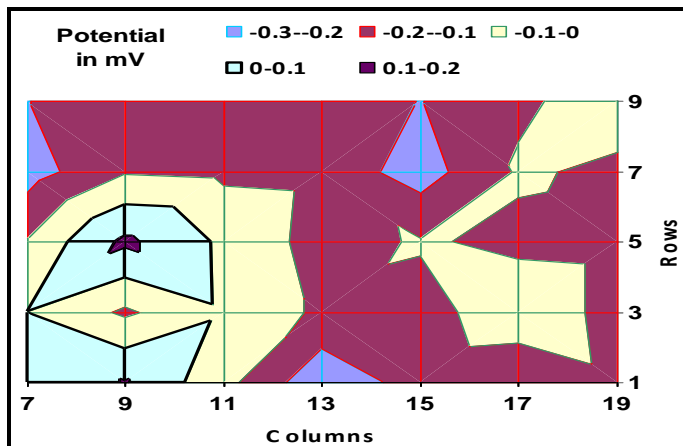
6.2. Pier 2

Only 33% region falls in 'D' category depicting uncertain corrosion activity while remaining 67% (20% in 'E', 16% in 'F' and 31% in 'G') area falls in categories which are indicative of no noticeable corrosion activity in the scanned area of the pier.

Fig. 6.3 Contour Map Showing Corrosion Status

Fig. 6.4 Pie Chart of Scanned Area

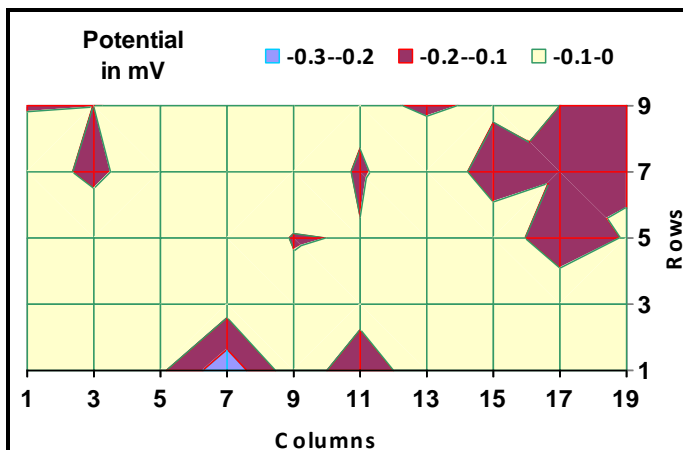
6.3. Pier 3

Only 2% region falls in D category depicting uncertain corrosion activity while remaining 98% (6% in 'E', 42% in 'F' and 50% in 'G') area falls in categories which are indicative of no noticeable corrosion activity in the scanned area of the pier.

Fig. 6.5 Contour Map Showing Corrosion Status

Fig. 6.6 Pie Chart of Scanned Area

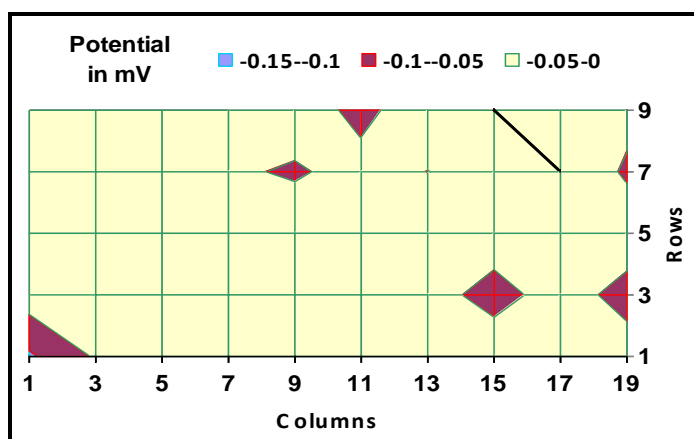
6.5. Pier 5

100% area (18% in 'F' and 82% in 'G') falls in categories which are indicative of no noticeable corrosion activity in the scanned area of the pier.

Fig. 6.9 Contour Map Showing Corrosion Status

Fig. 6.10 Pie Chart of Scanned Area

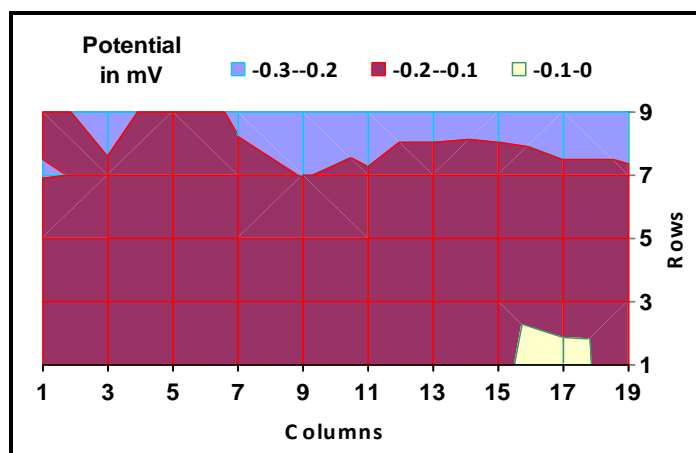
6.6. Pier 6

Only 14% region (2% in 'C' and 12% in 'D' category) depicts uncertain corrosion activity while remaining 86% (46% in 'E' and 40% in 'F') area falls in categories which are indicatives of no noticeable corrosion activity in the scanned area of the pier.

Fig. 6.11 Contour Map Showing Corrosion Status

Fig. 6.12 Pie Chart of Scanned Area

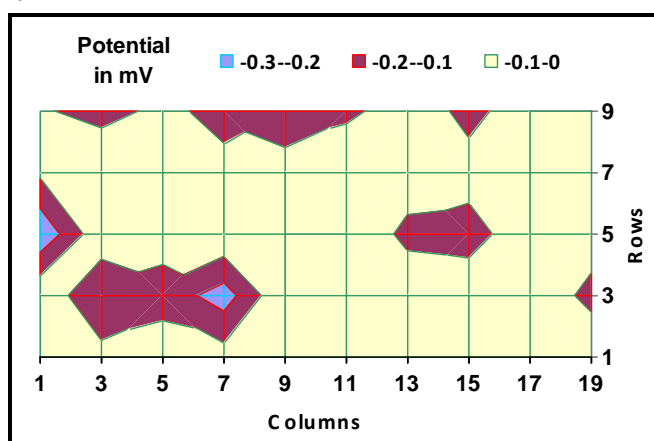
6.7 Pier 7

Fig. 6.13 Contour Map Showing Corrosion Status

Fig. 6.14 Pie Chart of Scanned Area

Only 4% region falls in ‘D’ category depicting uncertain corrosion activity while remaining 96% (4% in ‘E’, 23% in ‘F’ and 69% in ‘G’) area falls in categories which are indicatives of no noticeable corrosion activity in the scanned area of the pier.

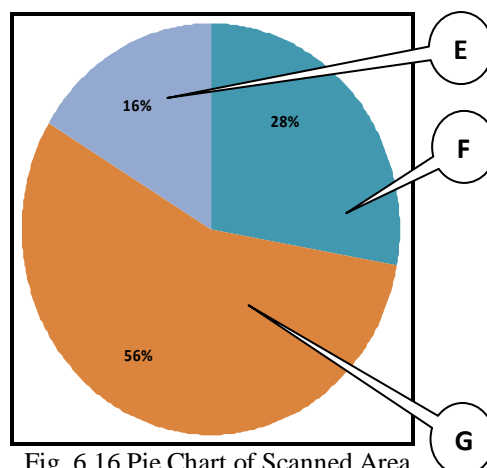
6.8. Pier 8 A

100% area (28% in ‘E’, 56% in ‘F’ and 16% in ‘G’) falls in categories which are indicatives of no noticeable corrosion activity in the scanned area of the pier.

Fig. 6.15 Contour Map Showing Corrosion Status

Fig. 6.16 Pie Chart of Scanned Area

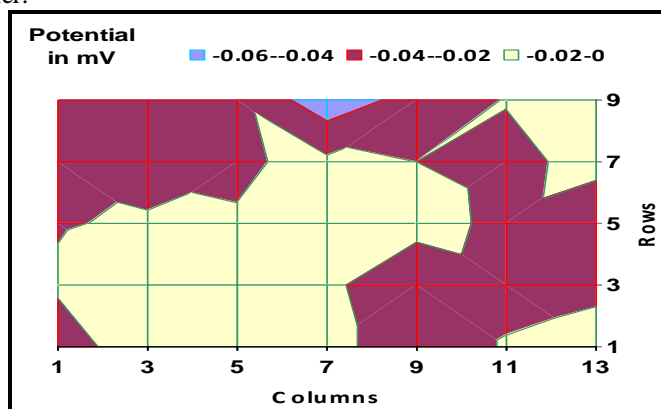
6.9. Pier 8 B

100% area falls in ‘G’ category which indicates no noticeable corrosion activity in the scanned area of the pier.

Fig. 6.17 Contour Map Showing Corrosion Status

Fig. 6.18 Pie Chart of Scanned Area

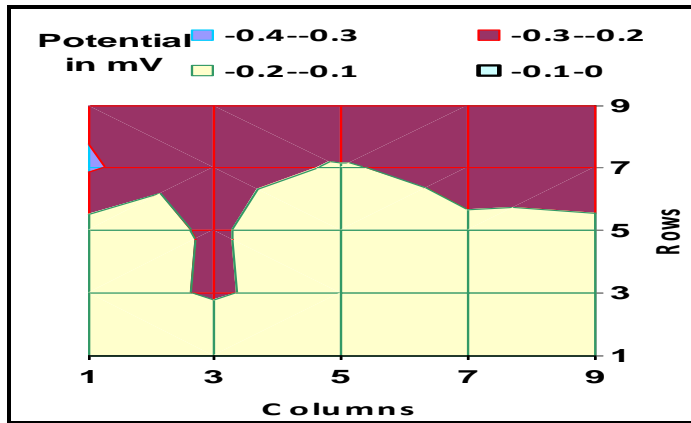
6.10. Pier 9

Fig. 6.19 Contour Map Showing Corrosion Status

Fig. 6.20 Pie Chart of Scanned Area

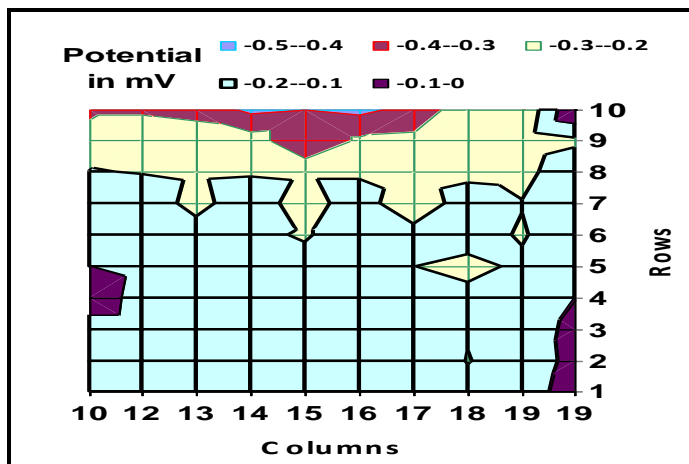
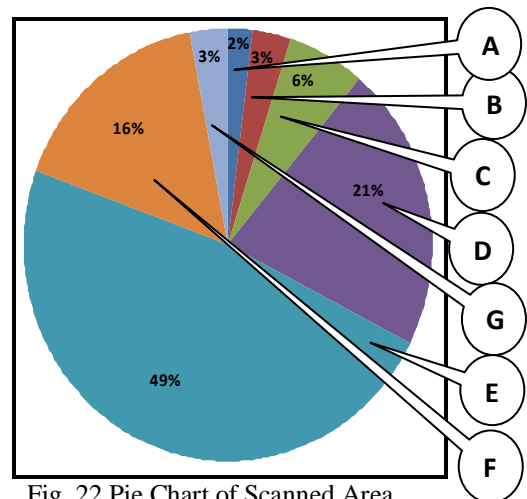
6.11. Pier 10

5% scanned area fall under categories 'A' & 'B', depicting , 90% chance of corrosion is occurring in this area whereas 27% area fall under categories 'C' & 'D' showing uncertain corrosion activity. 68% area (49% in 'E', 16% in 'F' and 3% in 'G' categories) falls in area which are indicatives of no noticeable corrosion activity in the scanned area of the pier. The general look of exposed rebar shown in figure 1 is also evident of vigorous corrosion activities in the area.

Fig. 6.21 Contour Map Showing Corrosion Status

Fig. 22 Pie Chart of Scanned Area
