Post-Event Evaluation and Assessment of Flash Flood Dam Efficiency

ABSTRACT: Flash flood dams are critical for mitigating downstream hazards, but their effectiveness depends heavily on robust design and construction. This study presents a post-event assessment of the Matrouh Dam in Egypt, a 6-meter-high embankment structure that failed to retain impounded water, releasing ~80% of its 200,000 m³ storage within 72 hours after its first flood event. Through integrated field investigations (including borehole sampling, land surveys, and visual inspections), laboratory permeability testing (ASTM D5084), and 2D finite element modeling (DIANA software), we identify the causes of premature water release. Three numerical scenarios were evaluated: (1) baseline design conditions, (2) an inefficient upstream riprap layer (simulating construction defects), and (3) a compromised core with doubled permeability. Results demonstrate that construction flaws—particularly mortar failure in the upstream riprap layer and elevated permeability in core materials—enabled rapid seepage through the dam body and foundation. Scenario 2 closely mirrored the dam's actual failure mode, underscoring the upstream

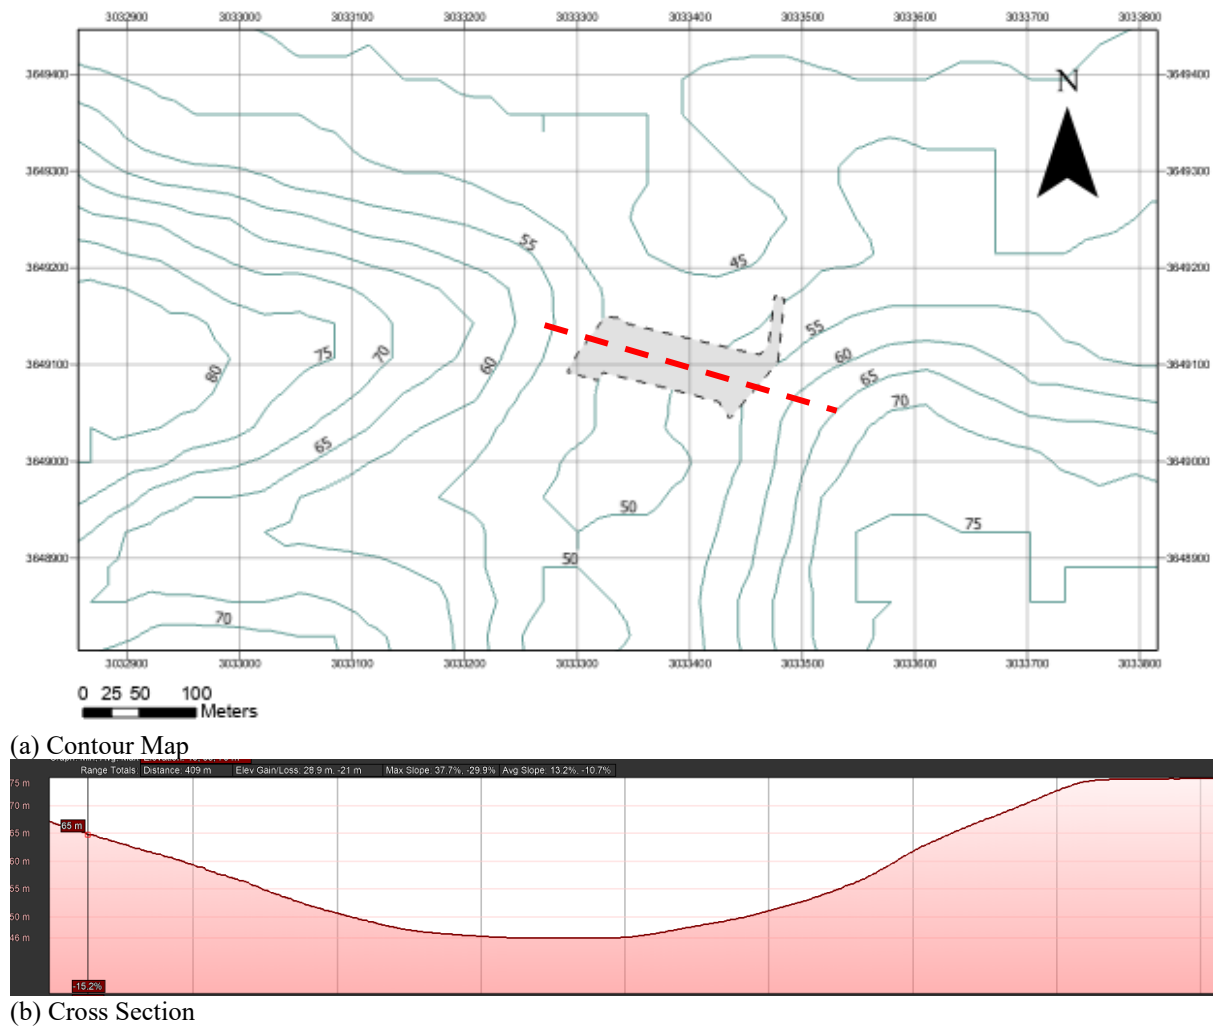
Figure 1: Dam location, Contour, and section

In 2023, a six-meter-high dam was constructed in Matrouh, Egypt. The dam's reservoir has a storage capacity of approximately 200,000 m³. The dam is located in a wide valley with a 500 m wide area surrounded by mountains 20 m higher. The slope of the mountains is steep, around 1:6.5 for the left bank and 1:15 for the right bank, as shown in Figure 1.

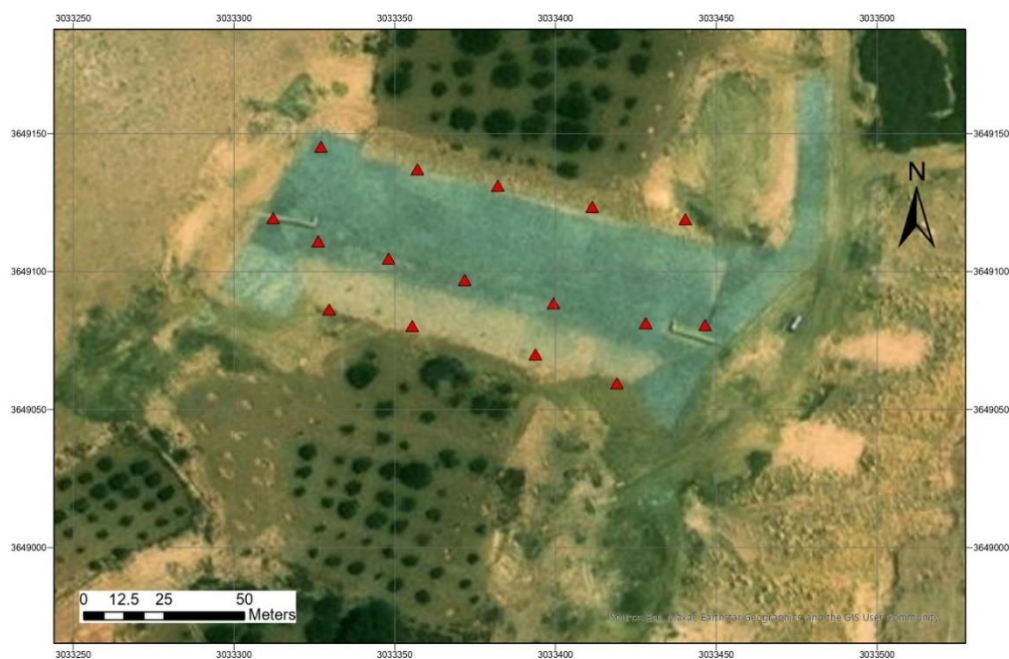
Figure 3: Matrouh Dam land survey points

Additionally, after the storm and the reservoir were empty, a land survey was implemented to check for deformations at 16 points distributed, Figure 3. The survey was periodically executed twice a month for three months during field tests to check the dam safety. Parallel to the land survey, SAR interferometry was studied as discussed in the previous sections and compared with the land survey results.

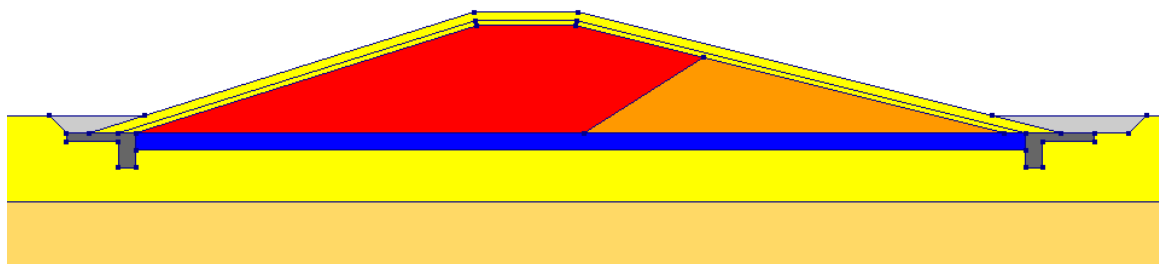
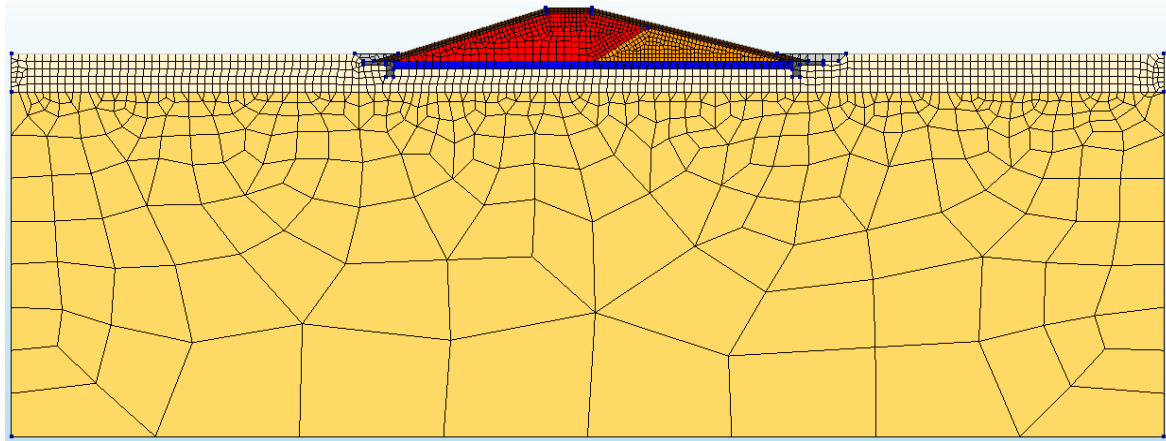
Figure 4: Dam Numerical Model

Material heterogeneity is incorporated to reflect the dam's zoned construction. Parameters such as young's modulus, Poisson's ratio, and permeability are calibrated to field data (Table 1 . Transient seepage analysis captures pore pressure evolution under reservoir loading. The model is validated with in-situ measurements and deformations, Figure 4

To identify the reasons for the high seepage and its effect on dam safety, numerical analysis using Diana software was used to study the impact of the upstream riprap layer on the dam stability (Figure 4. The model extended 3 times the dam width upstream and downstream, and five times the height of the dam [9]. The mesh sizes were determined according to the sensitivity of the hydraulic gradient and seepage discharge and varied from 0.5 to 2m for different zones of the dam.
