Short Communication

Modified Kanchan arsenic filters in Nepal: The current key factor to combat the arsenic crisis

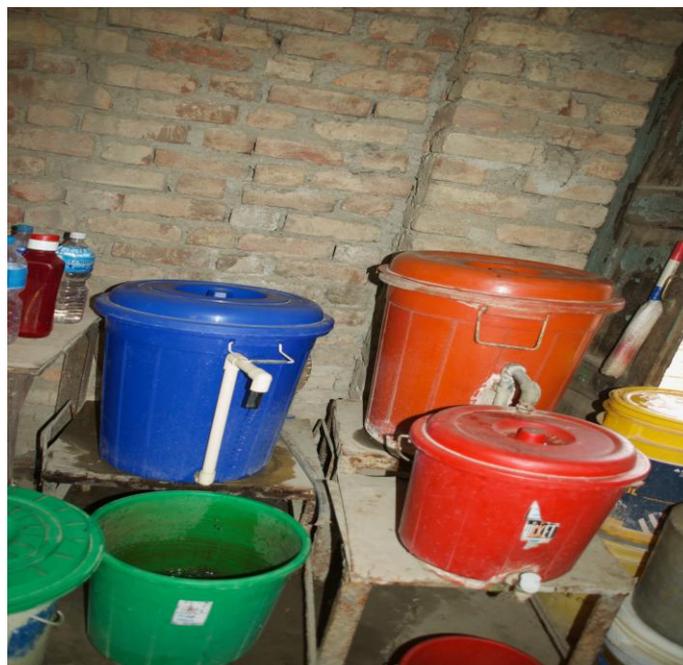
Figure 1. KAF with the outlet lower than the nail bed (red filter, old system) as well as the modified version of aKAF with the higher outlet (blue filter). Photo: B. Mueller, 9.4.2021.

Due to unforeseen global circumstances, 20 completely modified new KAF could only be installed in the province of Nawalparasi (Nepal) in spring 2021. Fig. 1 depicts an old filter with the outlet lower than the nail bed (red filter) as well as the filter filled with new material (nail and sand) and a higher outlet (blue filter). An upper sand bed was applied in order to avoid the nails to dry out and to keep them in place. These filters were closely monitored and water samples (ground water, water after nailbed and filtered water) were taken repeatedly for one year. The newly installed filters were working perfectly and independently of the arsenic concentration of the ground water filtered As below the WHO guideline of $10 \mu\text{g/l}$. The majority of the filters still eliminated As below the WHO guideline according the analyses of July and November 2021. The others were still capable of filtering As to less than $50 \mu\text{g/l}$ - the interim guideline in Nepal. Analyses from April 2022 are currently evaluated and the results of this one-year-monitoring will be published in detail shortly. As Mueller and Hug[13] already stated, it is imperative the replace the lower fine sand bed every year as the intake capacity of this sand is crucial in order to achieve satisfying elimination results as the declining removal efficiency of some of the KAFs installed in April 2021 is clearly related to the decreasing filtering function of the lower sand bed.
